Brisbane Central Business District Bicycle User Group

CBD BUG

The Brisbane Central Business District Bicycle User Group (CBD BUG) is concerned about existing and reinstated deflection rails (known colloquially as “banana bars”) in the Brisbane City Council area. Our members and other people who ride bikes frequently complain of their dangerous nature and inappropriate use.

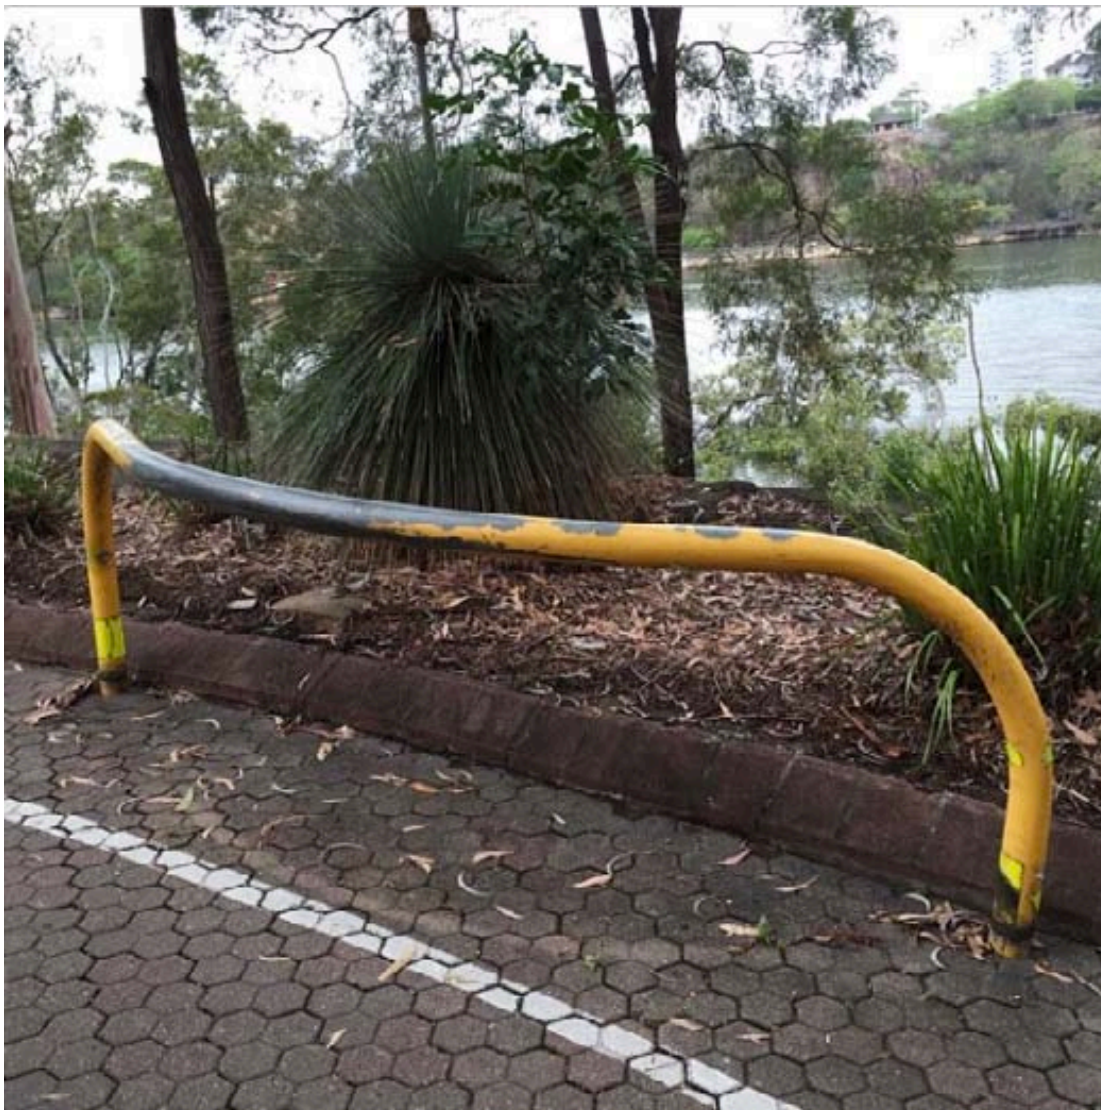
- Riverstage – the BUG requested removal of these bars on 28 August 2014.

- They create a pinch point and increase the potential for crashes between path users.
 - The risk to cyclists from these bars is evident from virtually all their paint having been scratched off their horizontal sections due to numerous impacts by cyclists.

- In being located on a curve the sight lines for cyclists approaching these bars are restricted.
 - There is no need for these bars to be in place as a “slow down” device. According to the Shared Paths and Bicycle Path Termination Treatments (Page 16 of TMR TRUM Note Under Development 9 July 2013) data analysis has shown that the average speed of cyclists on shared path facilities at peak times approximates a reasonable design speed for individual locations.

- There is a barrier to vehicles entering this path at its Edward St termination. If a barrier is required at the Goodwill Bridge termination of this path – it should be at that site and not mid-path.

- It is suggested that at the time these banana bars were installed the volume of people riding bikes along this path was significantly lower than that now evident. Accordingly, these bars are no longer appropriate to this location.

These banana bars should be removed for the following reasons.

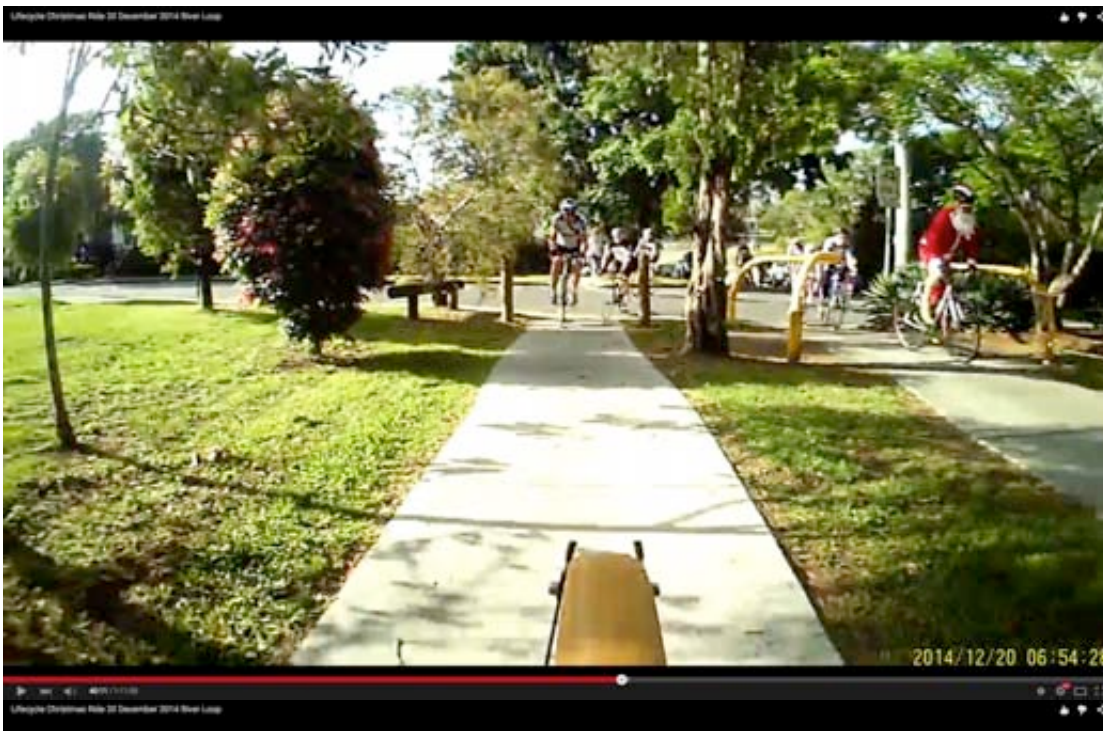
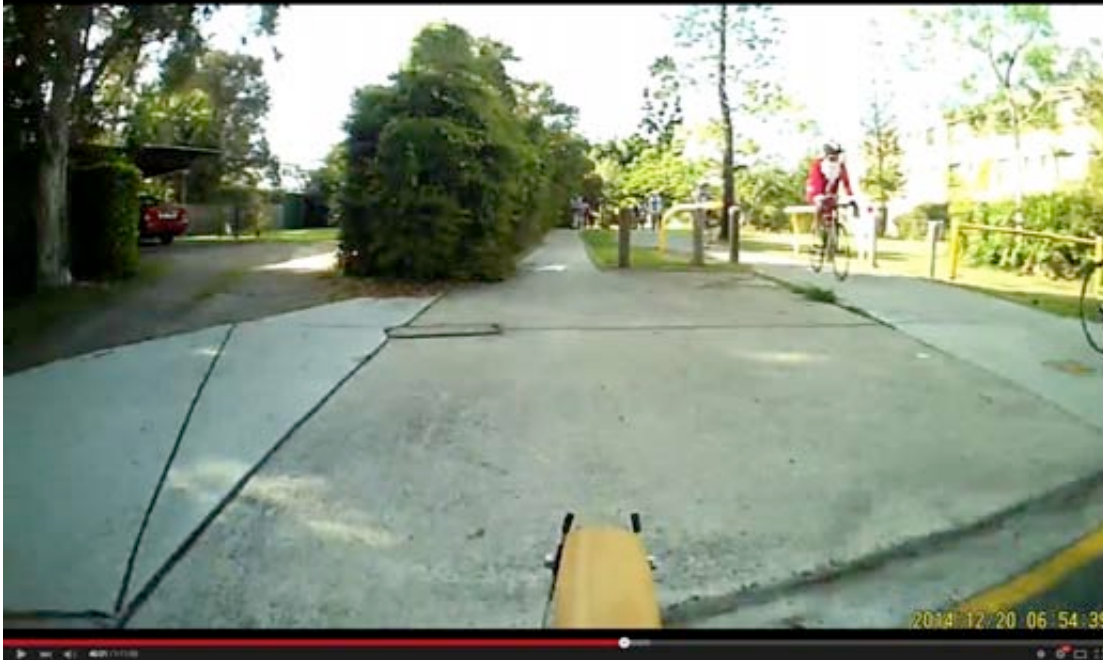
- Yeronga – two pairs at Stevens Street / Paragon Street – also see Appendix. These need to be removed plus the dangerous lip on the kerb on the north side needs fixing – see pictures. This infrastructure is now completely inadequate for the volume and speed of bicycle traffic that traverses this area as both commuter and recreational (“River Loop”) traffic.

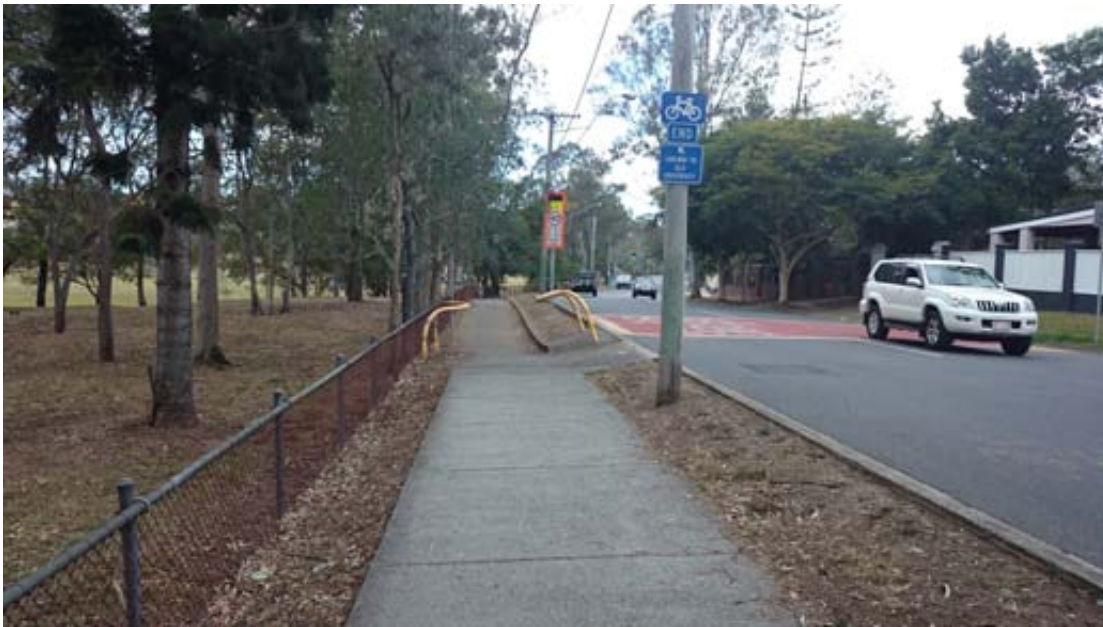
- St Lucia – on the Esplanade footpath (see Appendix) and on the footpath opposite the entrance to St Peter's College on Lambert Road (in photo). Both just add conflict between path users for no good reason.

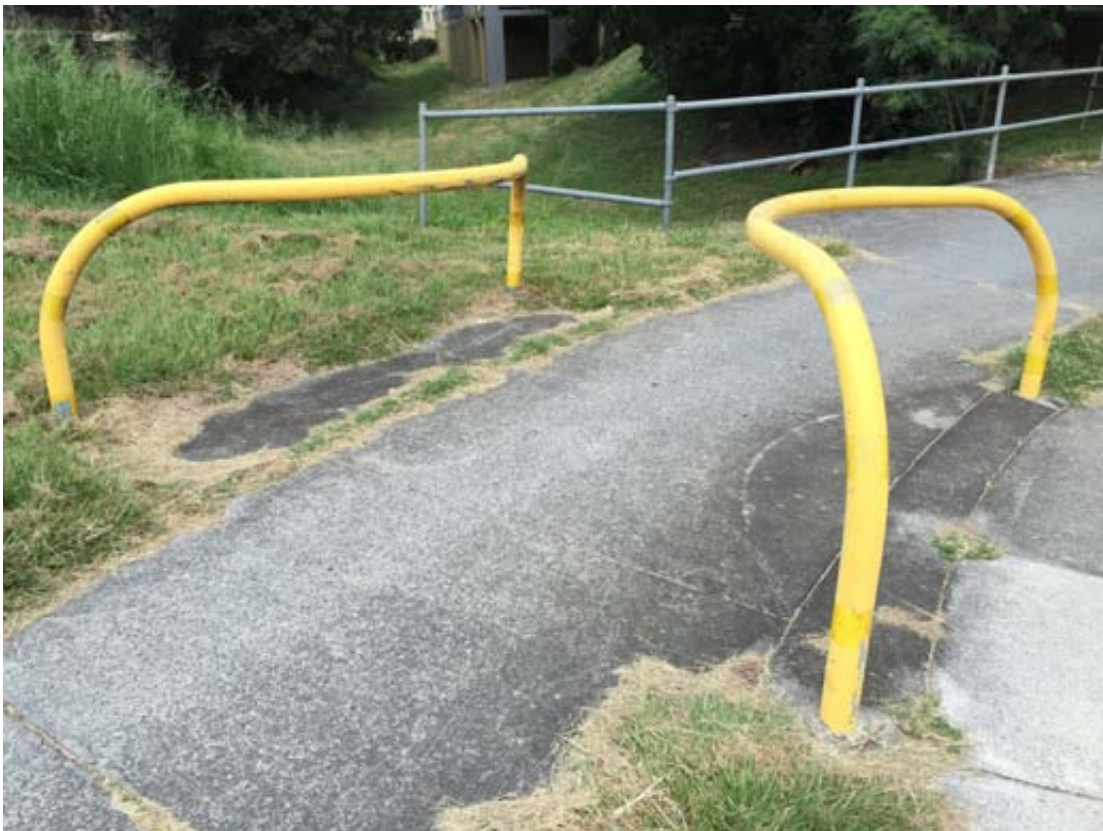
- Macquarie Street near University of Queensland. There is a project⁷ to remove the dangerous bars (pictured) near the creek, although it envisages replacing this pair with two other pairs. Another solution should be chosen. The BUG would also like to see the two pairs closer to the University east of this location removed as well. There is the single set of “banana” bars at the corner of Keith St and Macquarie St about 150 m further east from the Macquarie Street project, and another set some 200 m further east of that set where that bikeway meets Sir William Macgregor Drive (see Appendix). Given that these two locations service virtually identical volumes of bicycle traffic we request that they are given similar treatment and be replaced with more appropriate high volume bike path entrance treatments.

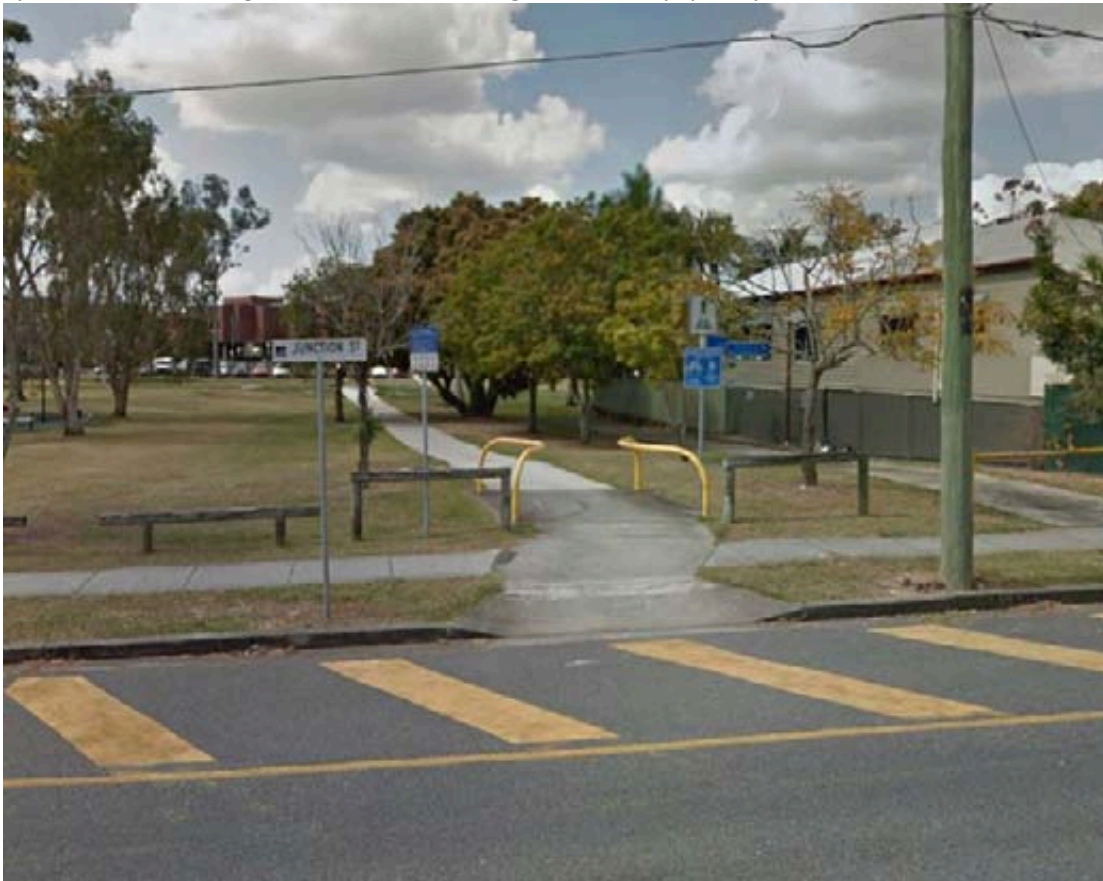
- Junction Street. This street can get pretty busy at times but the presence of banana bars prevents cyclists from crossing the road and entering the Bikeway quickly.

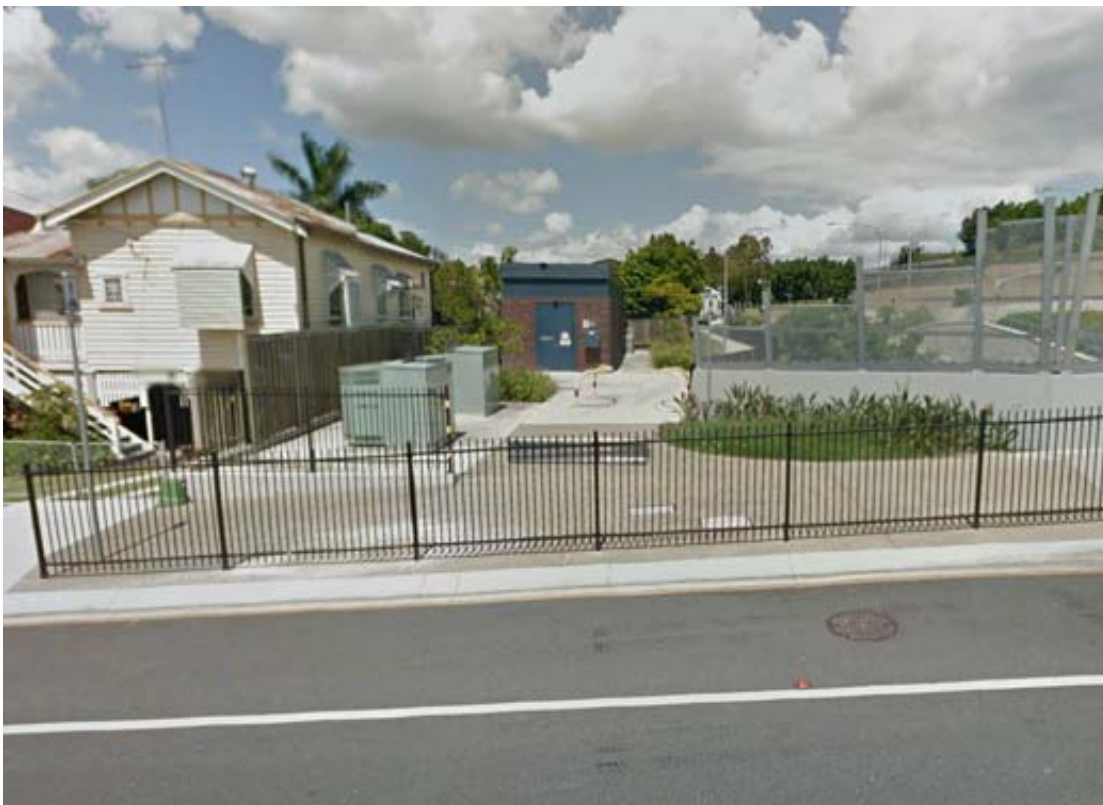
- Between O'Keefe Street and Fern Street. Cyclists travelling towards Fern Street often ride to the left of the two bars which defeats their purpose.

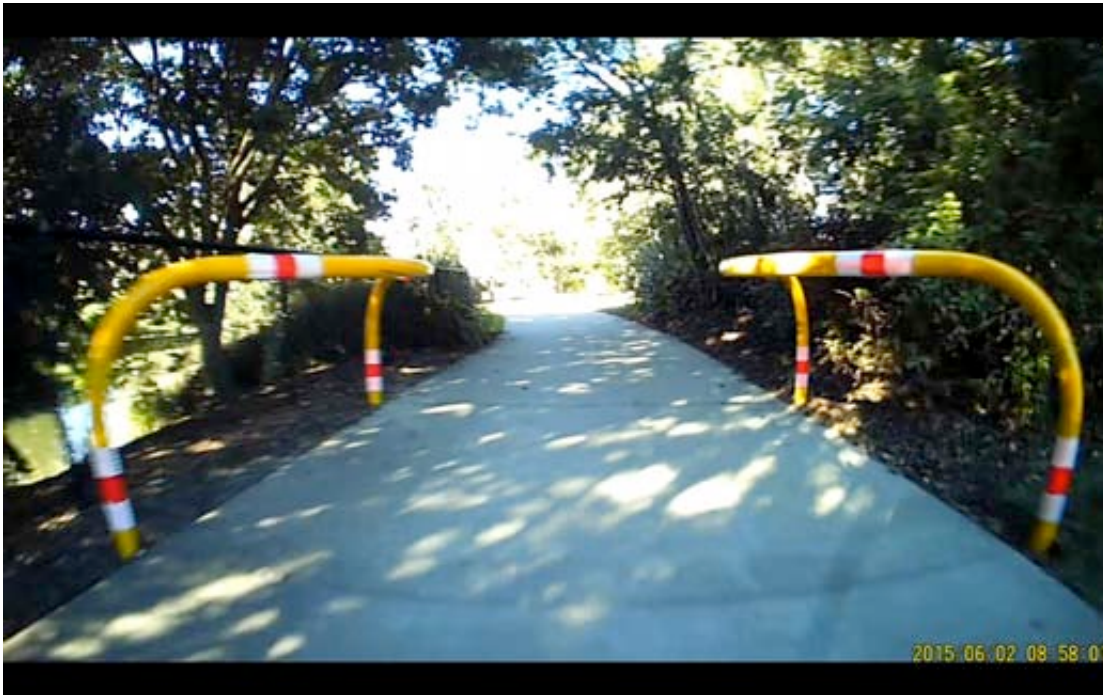
- Yorks Hollow on the Normanby Pedestrian Cycle Path, near the west end of Gilchrist Avenue. These have been reinstated after recent Legacy Way works.
