Brisbane Central Business District Bicycle User Group

CBD BUG

The Brisbane Central Business District Bicycle User Group (CBD BUG) is concerned about existing and reinstated deflection rails (known colloquially as “banana bars”) in the Brisbane City Council area. Our members and other people who ride bikes frequently complain of their dangerous nature and inappropriate use.

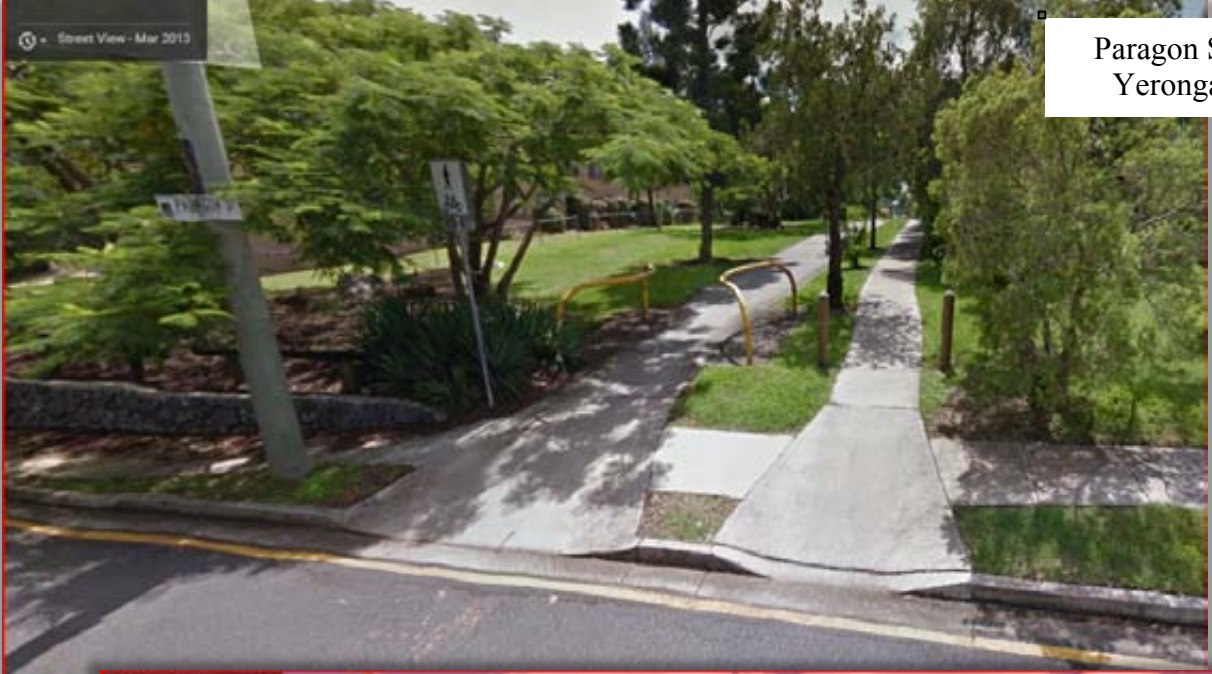
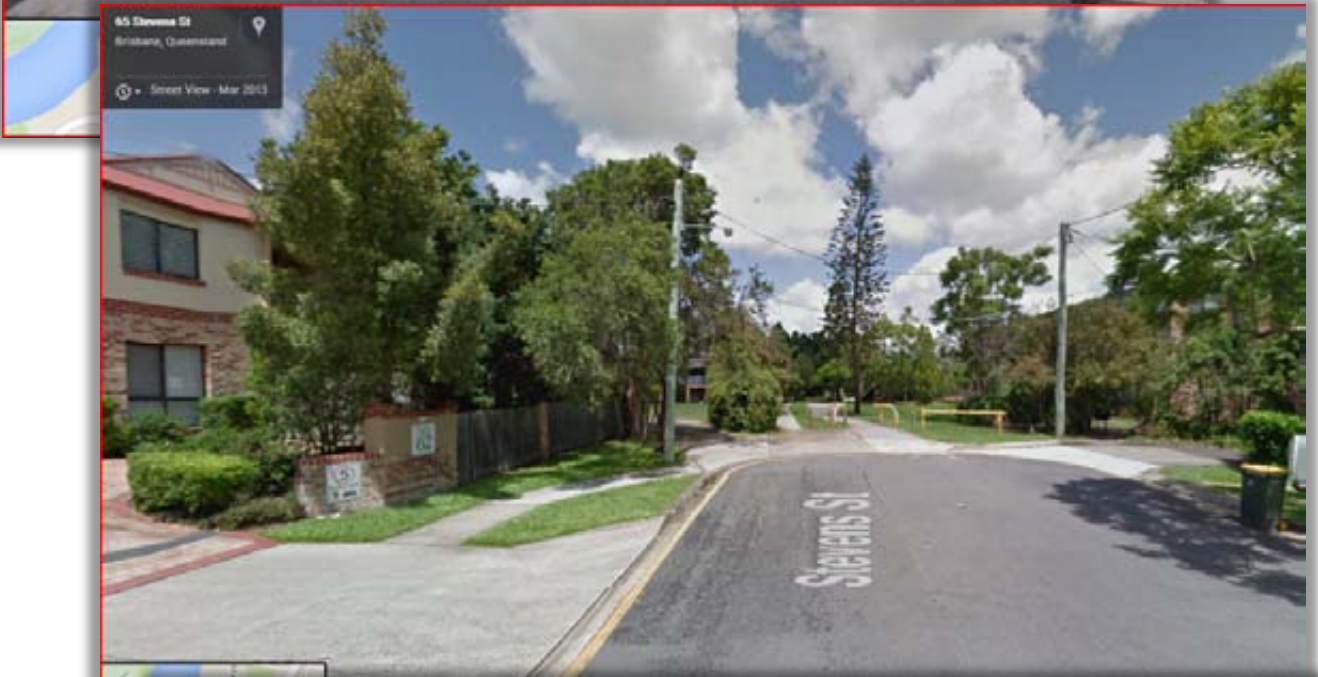
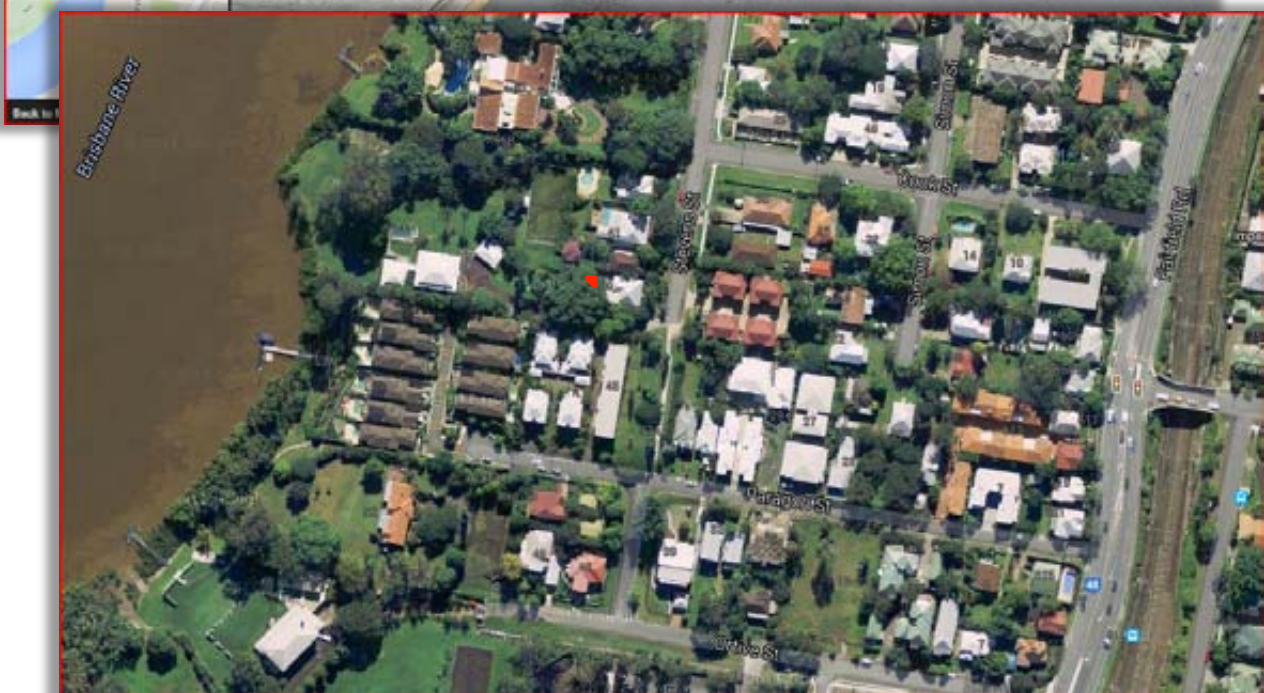
Paragon St,
Yeronga

- Yeronga – two pairs at Stevens Street / Paragon Street – also see Appendix. These need to be removed plus the dangerous lip on the kerb on the north side needs fixing – see pictures. This infrastructure is now completely inadequate for the volume and speed of bicycle traffic that traverses this area as both commuter and recreational (“River Loop”) traffic.

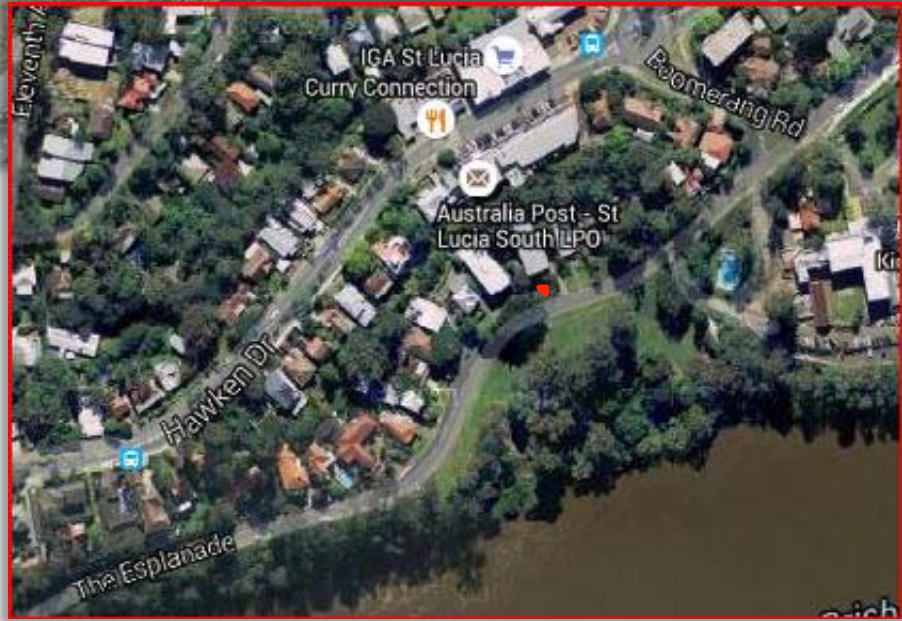
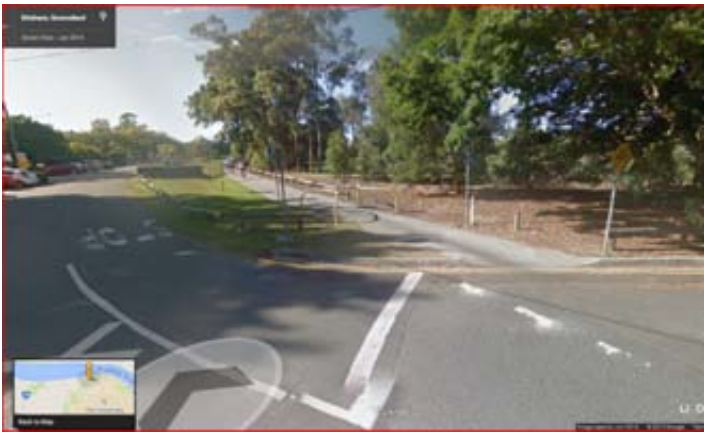
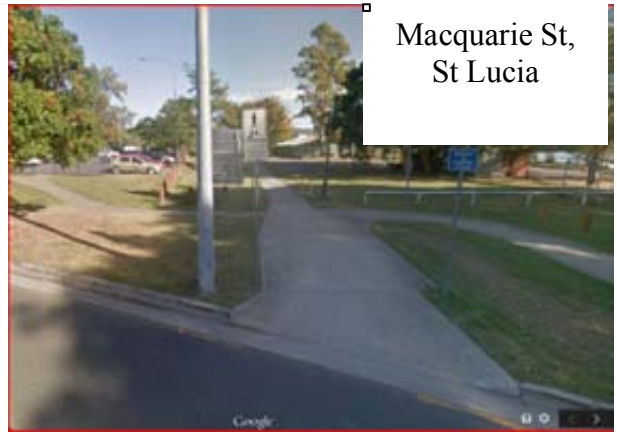
The Esplanade,
St Lucia

- St Lucia – on the Esplanade footpath (see Appendix) and on the footpath opposite the entrance to St Peter's College on Lambert Road (in photo). Both just add conflict between path users for no good reason.
